Technical Service BULLETIN

SQUEAK & RATTLE SERVICE TIPS

'00 MR2 Spyder

NVH
NV011-00

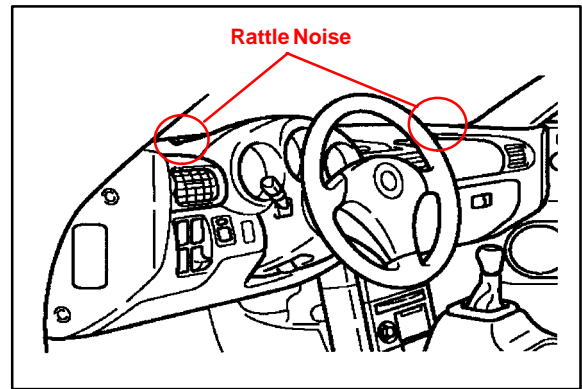
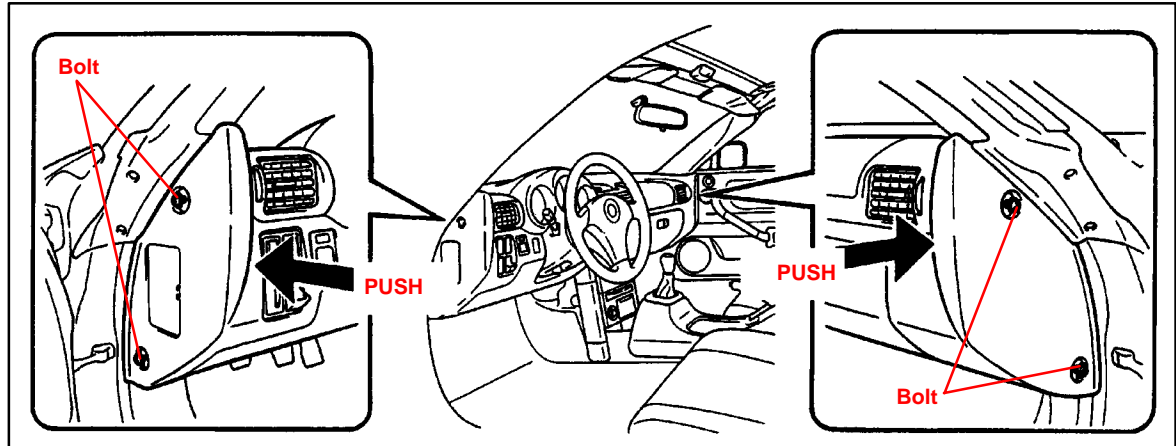
Instrument Panel Rattle Noise

To eliminate a rattle noise from the upper instrument panel area:

1. Loosen the two (2) bolts on each side of the instrument panel.
2. While another technician pushes forward on the instrument panel, retighten the bolts as shown below.

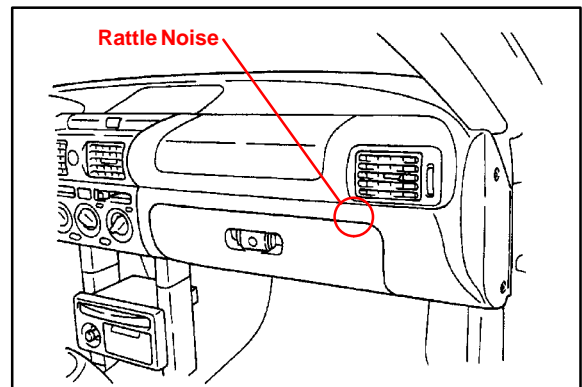
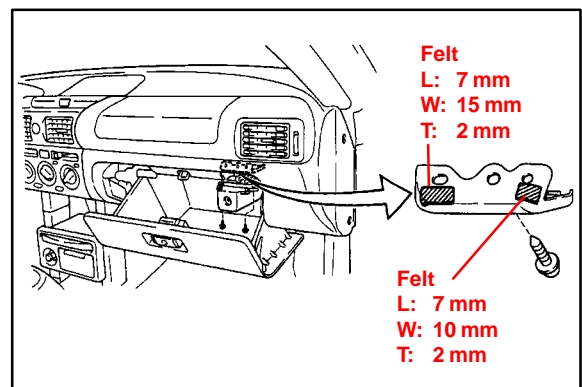
**Passenger Airbag Cutoff Switch
Rattle Noise**

To eliminate a rattle noise from the airbag cutoff switch area:

1. Remove the two (2) bolts that hold the passenger airbag cutoff switch in place.
2. Cut two (2) pieces of felt in the following dimensions:

QTY	L	W	T
1	7 mm	15 mm	2 mm
1	7 mm	10 mm	2 mm

3. Fit felt pieces in the positions shown.
4. Reassemble in the reverse order of disassembly.

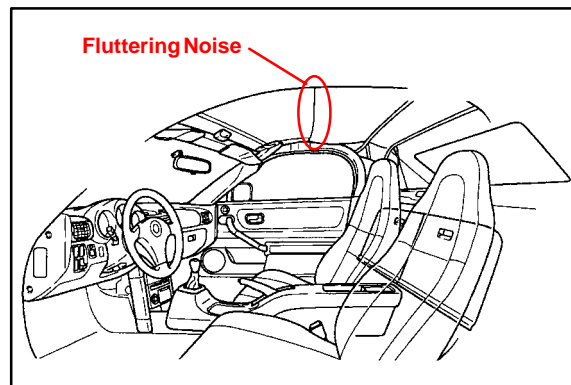
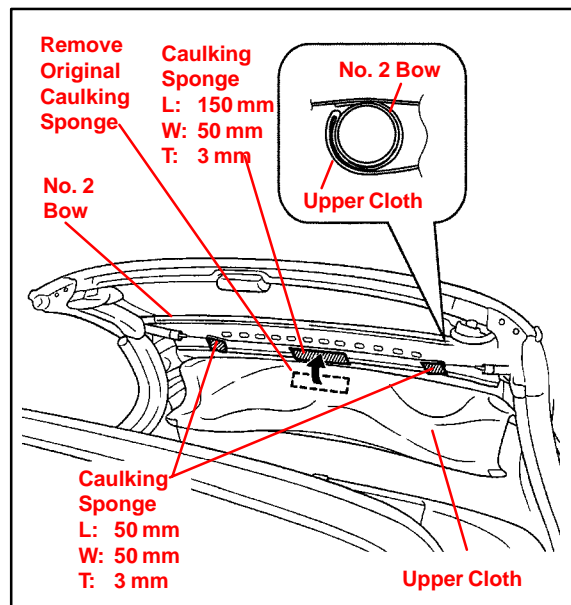
Convertible Top Fluttering Noise

To eliminate a fluttering noise from the convertible top number 2 bow:

1. Remove the convertible top upper cloth (refer to the 2000 MR2 Spyder Repair Manual, pages BO-77 to BO-78).
2. Remove EPT Sealer (caulking sponge) from the center of the inner upper cloth (see illustration).
3. Clean area with Kent® Acrysol (or equivalent).
4. Cut three (3) pieces of EPT Sealer (caulking sponge) in the following dimensions:

QTY	L	W	T
1	150 mm	50 mm	3 mm
2	50 mm	50 mm	3 mm

5. Install EPT Sealer (caulking sponge) in the positions shown.
6. Reassemble in the reverse order of disassembly.

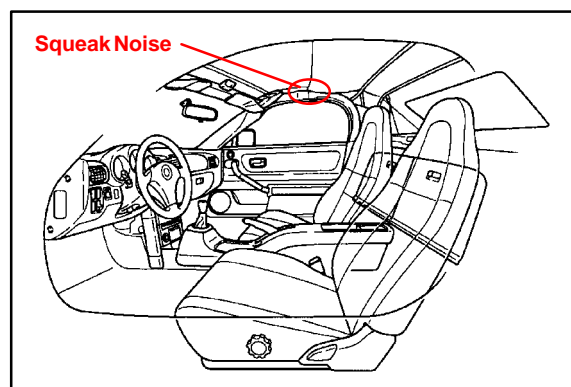
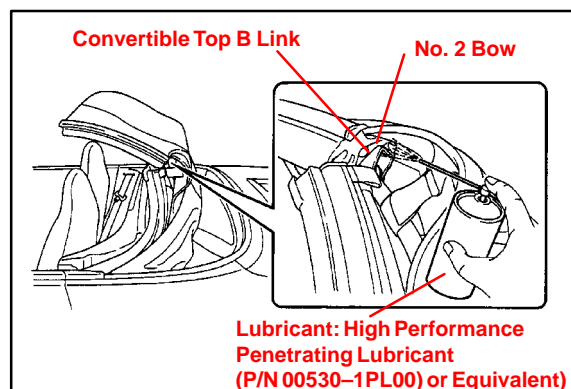
Convertible Top B Link Squeak Noise

To eliminate a squeak noise from the convertible top B link:

1. Open the convertible top to a half-open position.
2. Spray High Performance Penetrating Lubricant (P/N 00530-1PL00) or equivalent in the area shown, being careful to avoid overspray on interior components.
3. Wipe off excess lubricant.

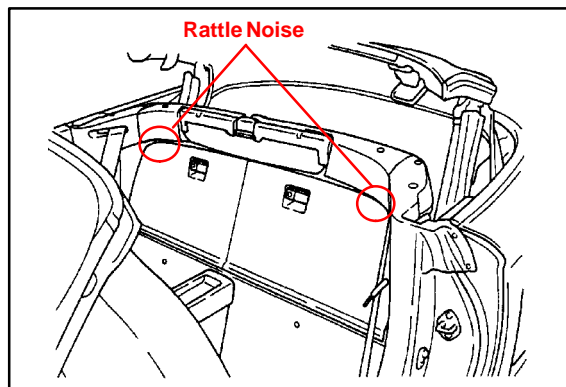
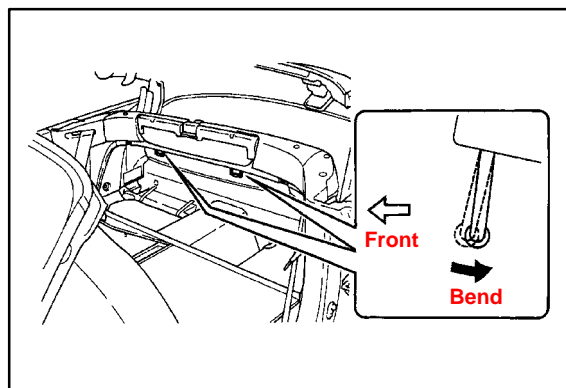
Luggage Compartment Lid Rattle Noise

To eliminate a rattle noise from the luggage compartment lid:

1. Bend the luggage compartment lid striker approximately 3 mm rearward as shown.

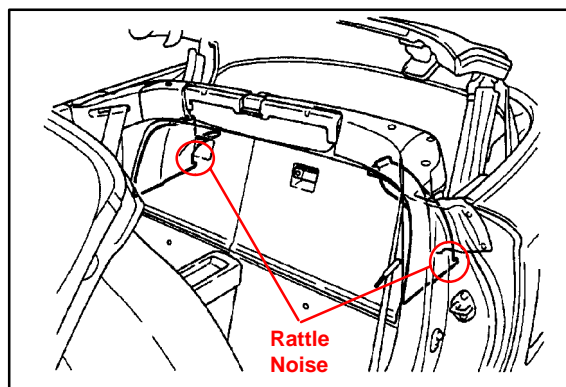
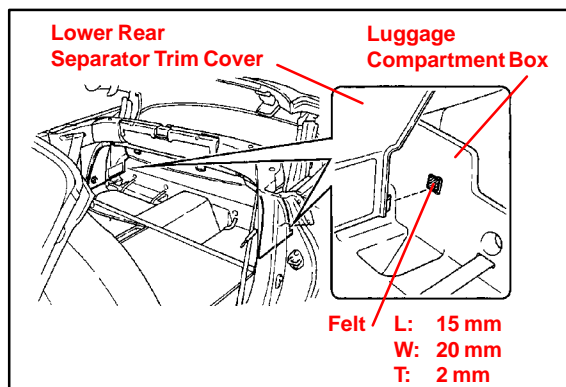
Luggage Compartment Lower Rear Separator Trim Cover Rattle Noise

To eliminate a rattle noise from the luggage compartment lower rear separator trim cover:

1. Cut two (2) pieces of felt in the following dimensions:

QTY	L	W	T
2	15 mm	20 mm	2 mm

2. Install felt in the positions shown.

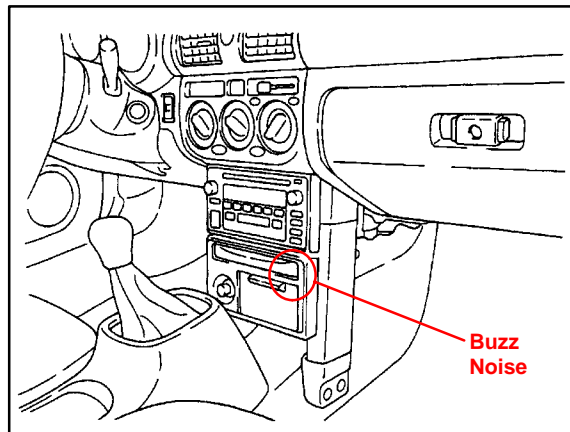
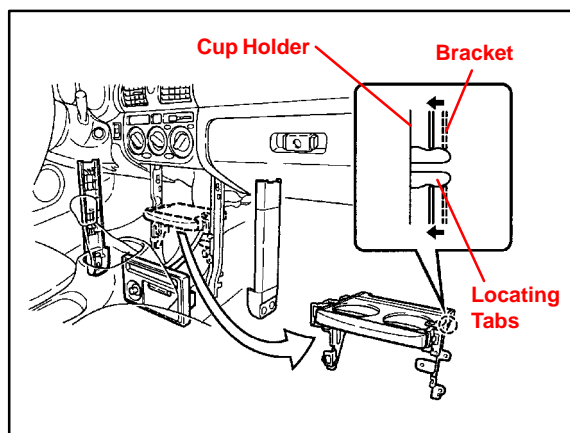
Cup Holder Buzz Noise

To eliminate a buzz noise from the cup holder area:

1. Remove cup holder assembly (refer to the 2000 MR2 Spyder Repair Manual, page BO-42).
2. Reposition cup holder brackets as shown.

It may be necessary to spread the locating tabs slightly for tighter fit.

3. Reassemble in the reverse order of disassembly.

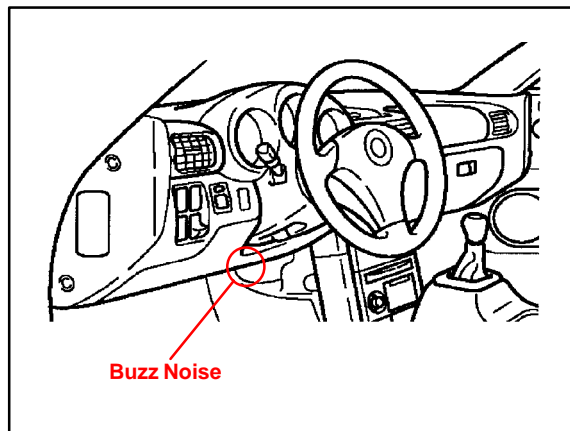
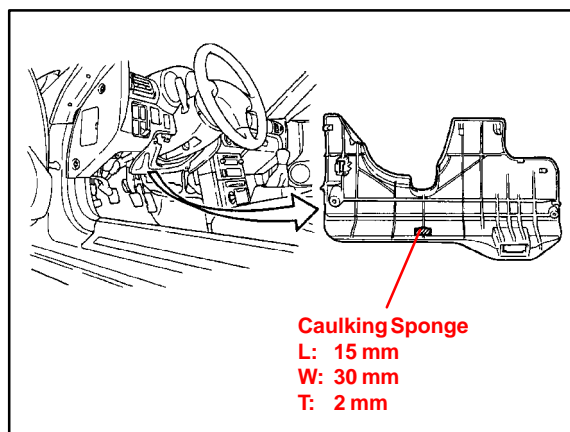
Instrument Panel Lower Finish Panel Buzz Noise

To eliminate a buzz noise from the No. 1 lower finish panel area:

1. Remove the No. 1 lower finish panel.
2. Cut a piece of EPT Sealer (caulking sponge) in the following dimensions:

QTY	L	W	T
1	15 mm	30 mm	2 mm

3. Install EPT Sealer (caulking sponge) in the position shown.
4. Reassemble in the reverse order of disassembly.

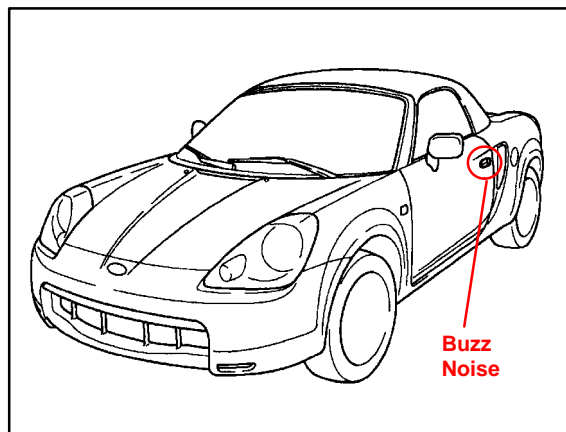
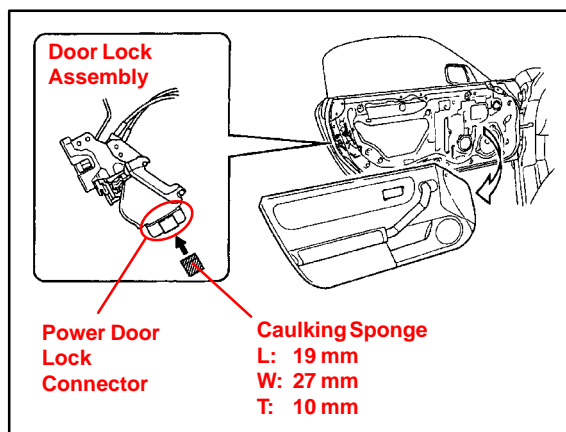
**Repair
Procedure**
(Continued)**Outside Door Handle Area Buzz Noise**

To eliminate a buzz noise near the outside door handle area:

1. Remove the door trim panel (refer to the 2000 MR2 Spyder Repair Manual, pages BO–12 to BO–13).
2. Cut a piece of EPT Sealer (caulking sponge) in the following dimensions:

QTY	L	W	T
1	19 mm	27 mm	10 mm

3. Install EPT Sealer (caulking sponge) on the power door lock connector in the position shown.
4. Reassemble in the reverse order of disassembly.
